Guide Dogs for the Blind Association

Before and After Surveys of Changes to New Road Brighton

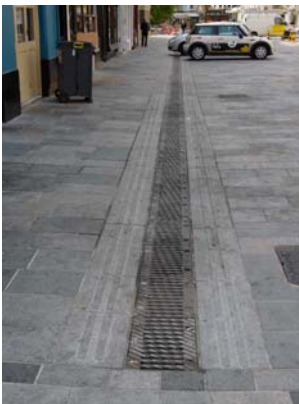
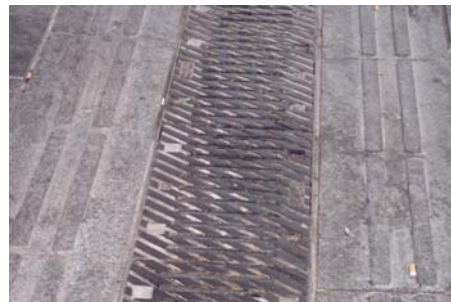
Fig 1
Figures 1 and 2: Tactile strip

The after surveys were conducted in June 2007 following the redevelopment of the street into a shared surface area. The new street design includes a drain with “tactile” strips on either side of the drain as a guidance path along one side of the road – fig 1. The “tactile” strip used does not conform to the 'Guidance Paving' specified in the Department for Transport’s “Guidance on the use of tactile paving surfaces” either in profile or layout – fig 2. There is no colour or tonal contrast between the “tactile” strips and the surrounding surface. On the other (theatre) side there is no “tactile” strip.

Participants reported that there were no orientation cues, no boundaries, no colour contrast, and that the “tactile surface” was not definitive enough. Some individuals could not distinguish the “tactile paving” with one saying it felt like ‘stepping on a cigarette packet or crumpled paper’. Others missed the “tactile” completely. The open space with no distinct colour or tonal contrast was noted by participants.

- The “tactile” paving to the one side of the street should be replaced with tactile paving which conforms to the profile and layout of the specification for guidance paving in the Tactile Paving Guidance

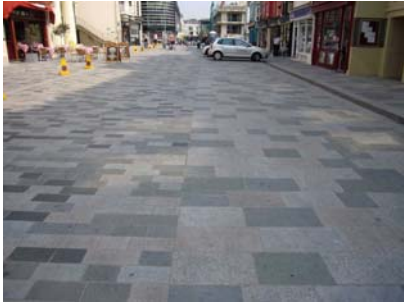
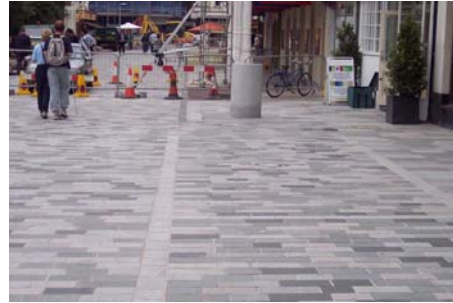
Fig 3
Figures 3 and 4: shared surface

“One huge open space. No clues.”

- A ‘safe space’ should be provided to either side of the area to enable blind and partially sighted people, and other vulnerable pedestrians, to be confident they are away from traffic. The safe spaces must be clearly detectable with a physical surface delineation and colour/tonal contrast.

- (Department for Transport) and clearly contrasts in tone with surrounding paving.
- A tactile demarcation should be provided to the theatre side of the street. This could again be guidance paving. If another form of demarcation is used this should be tested to ensure it is appropriate, that it can be detected by blind and partially sighted people and that it doesn't impede the movement of other disabled people.

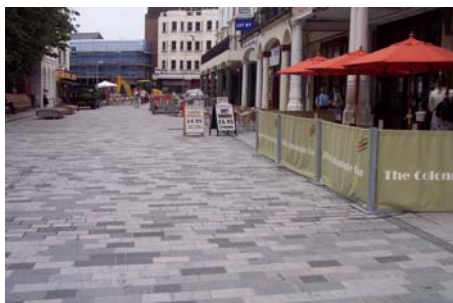
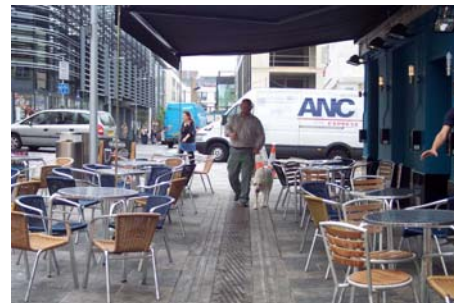
Fig 5
Figures 5 and 6: Café tables and chairs

Café tables and chairs were noted to be obstructing the area between the “tactile” strip and the building line. In some instances they were positioned on the “tactile” strip itself. On the theatre side of the street café tables and chairs were near to the building line, where they created obstructions.

- Street furniture and café tables and chairs should be sited in designated areas, maintaining a clear 'safe space' between the building line and the tactile demarcation. Providing a colour/tonal contrast between street furniture and the paving will be of benefit to people with some residual vision.
